BSR Home Inspection, LLC

# Home Inspection Report

**145 Main St, Sparta , TN 38583**

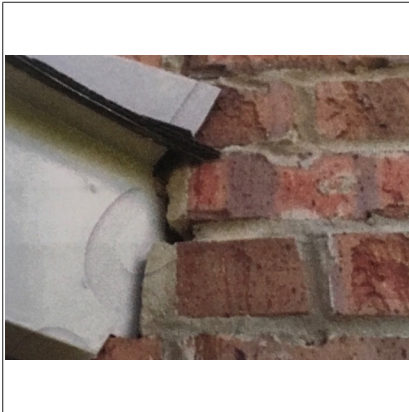
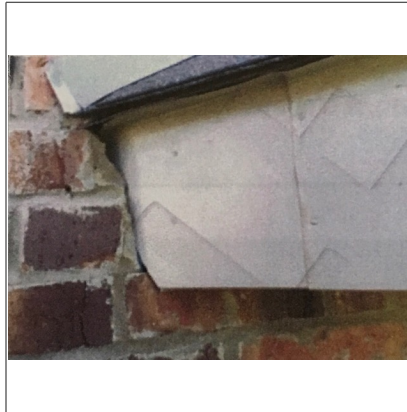
## Caulking

**Condition**  None  
 Satisfactory  Marginal  Poor  
 Recommend around windows/doors/masonry ledges/corners/utility penetrations  
**Comments**  
**Photos**
